NX Problem Solving Sheets

4425K EN 20160930 1030

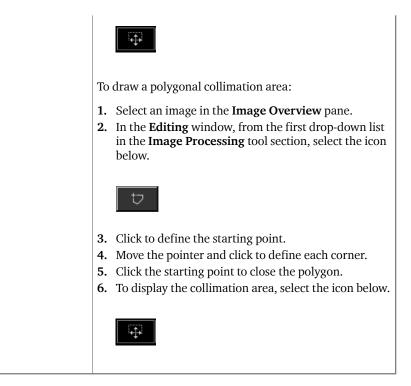
Part of the image is masked by the black border

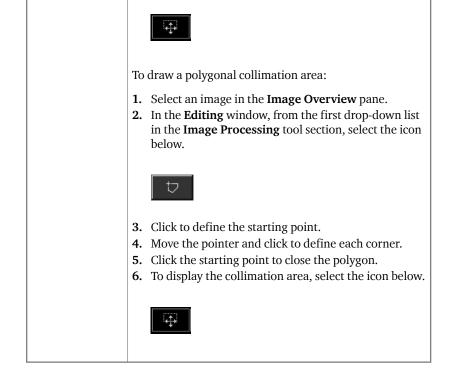
Details	NX is not active, no activity takes place.	
Cause		
Brief Solution	First check on the Windows taskbar if NX is running.Otherwise look in the Start Menu to start NX.You can also choose to reboot the system from the Start Menu.	
Solution Steps	 If you see NX in the taskbar, click NX in the taskbar. The NX application appears. Alternative solution: 1. Click the NX start icon in the Windows Start menu or the shortcut icon on the desktop.
